STINSON LAKE DAM
NH 00399

PHASE I INSPECTION REPORT
NATIONAL DAM INSPECTION PROGRAM

OCTOBER 1978

Name of Dam: Stinson Lake Dam, I.D. NH 00399
State Located: New Hampshire
County Located: Grafton
Stream: Stinson Brook
Date of Inspection: June 5, 1978

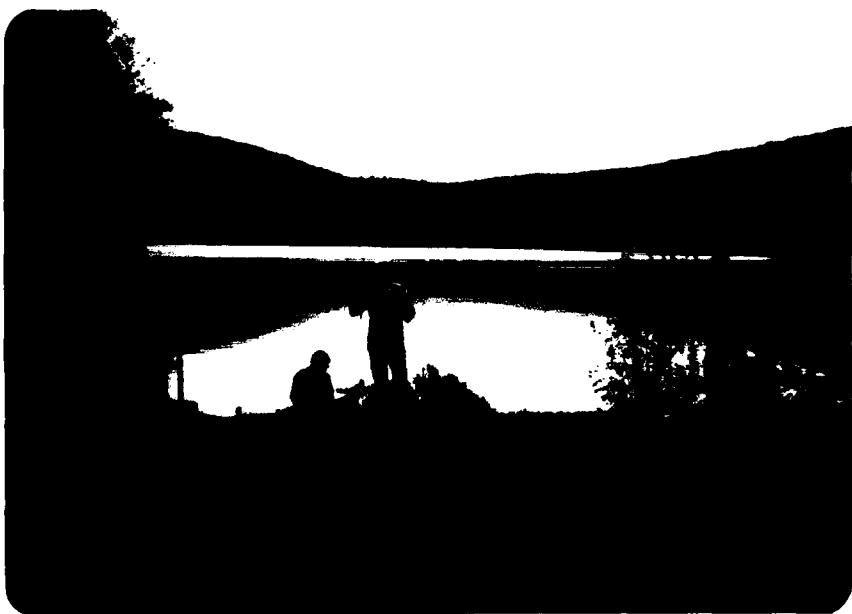
In general, up to a point 6 to 10 feet above the lake level, the lake rim is fairly flat, and then it slopes upward more sharply. No signs of instability of the terrain around the lake are readily apparent. The lake shore area is covered by trees and is sparsely developed. The shore is in the natural state and not protected against shoreline erosion except as noted above in the vicinity of the upstream spillway wing-walls. There are some signs of sedimentation at the right side of the spillway, where the approach channel appears to be significantly shallower than indicated on the dam drawings.

Photo 4 - View of the rim of Stinson Lake taken from the left abutment of the dam.
